Michael Sedillo Property Inspections

Property Inspection Report

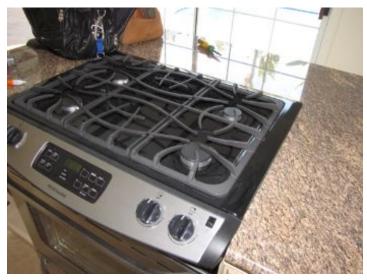
Kitchen stove does not appear to have venting (no hood above or downdraft below)

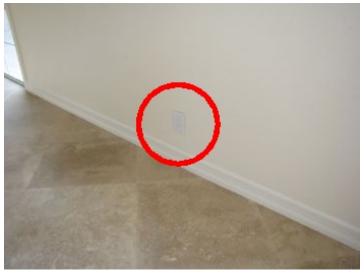
Loose electrical box in kitchen wall

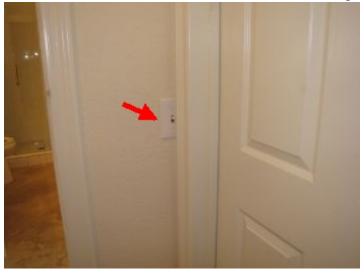
Light switch in hallway buried under molding

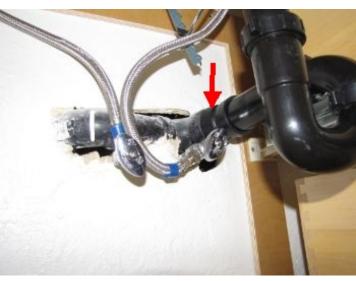
- The sink stopper handle mechanism is not connected in the 1st floor bathroom.
- There is a plumbing leak emanating from the ABS (black plastic) drain line in the sink cabinet of the 1st floor bathroom.

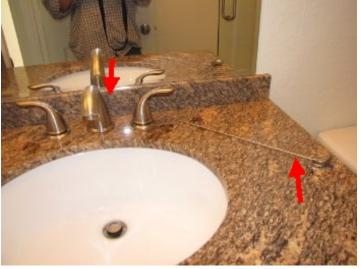
Leak in drain pipe below sink in 1st floor bathroom Drain stopper not connected in 1st floor bathroom sink

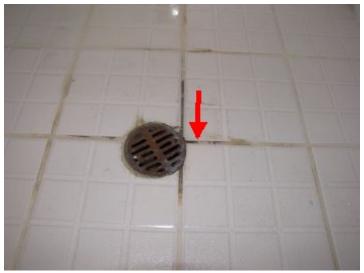
Spalled grout in 1st floor bathroom shower pan

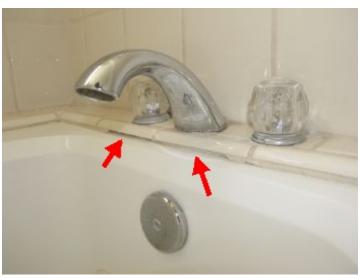
• The grout is spalling on the bathtub rim in the 2nd floor bathroom.

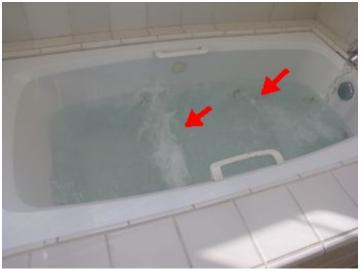
Spalling grout at 2nd floor bath tub rim

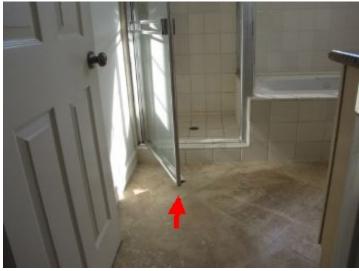
Shower door sweep at 2nd floor bathroom is deteriorated

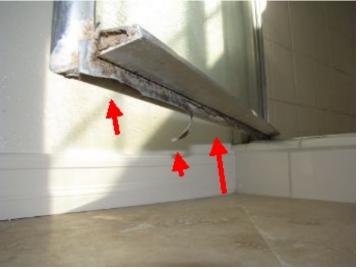
Deteriorated shower door sweep at 2nd floor bathroom

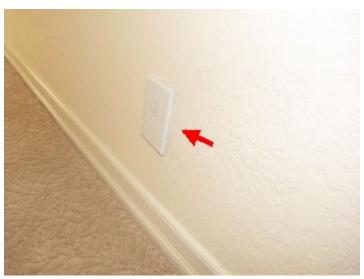
Loose electrical boxes in bedrooms

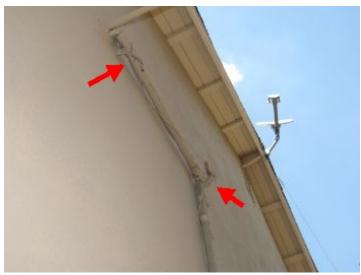
Insulation on Refrigerant lines is deteriorated

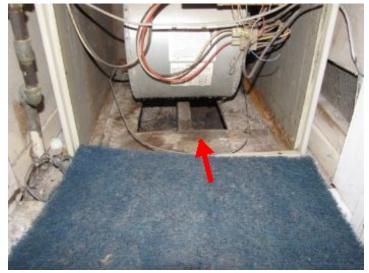
Holes cut for air passage appear small, recommend evaluation by HVAC technician

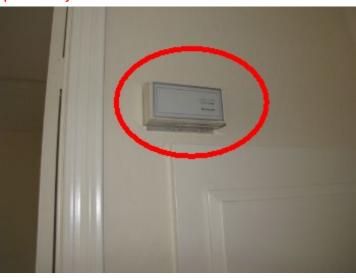
HVAC did not respond to thermostat, recommend evaluation by HVAC technician

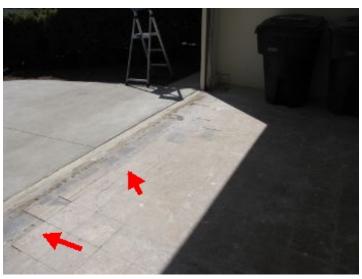
Loose & missing vinyl floor tiles in garage

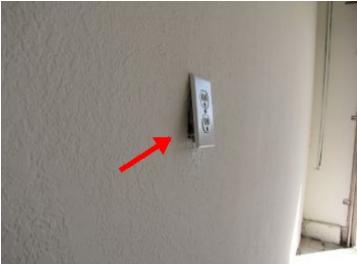
• The two outlets that back up to laundry room do not have power. The two outlet boxes that back up to the bedroom are loose but have power. The ceiling outlet has power.

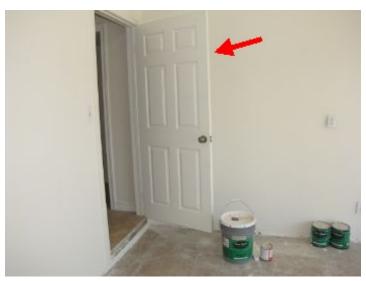
Non fire rated door to garage to interior

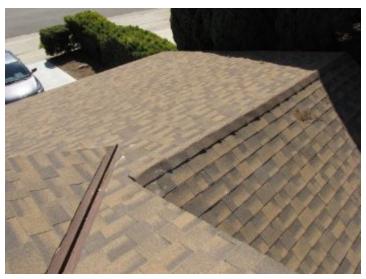
Roof is in overall good condition

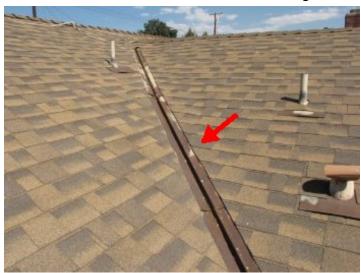
Suggest painting of valley flashing at roof to control rust scale (flashing is in satisfactory condition)

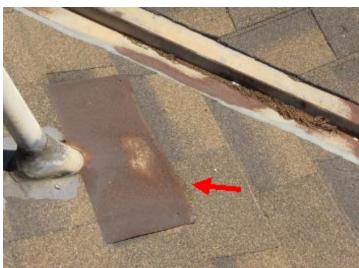
Suggest painting of vent flashing to control rust scale (flashing is in satisfactory condition)

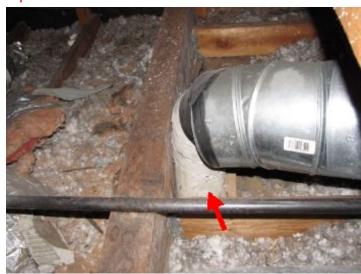
Un-determined duct material in attic, recommend evaluation for possible asbestos composition

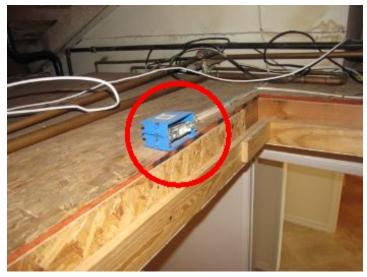
Missing cover plate at light switch box in attic

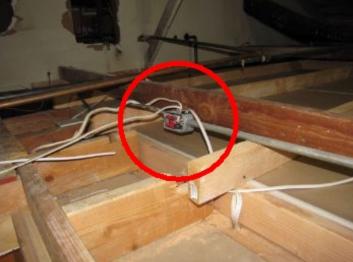
Cover plate missing at junction box in attic

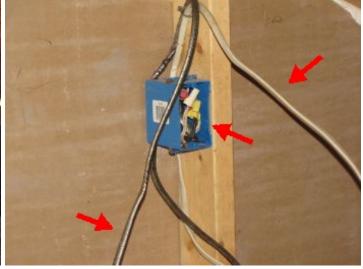
Missing cover plate and loose wires in attic

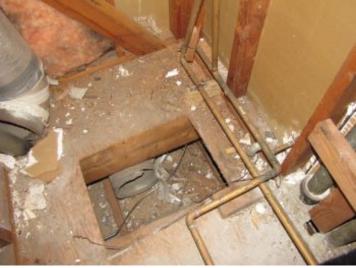
Debris and discarded ducting left in attic

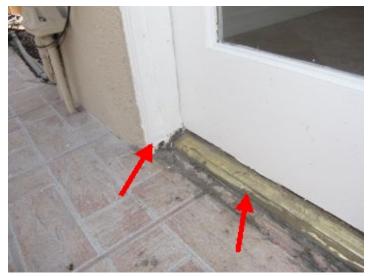
French doors affected by improper pool deck drainage

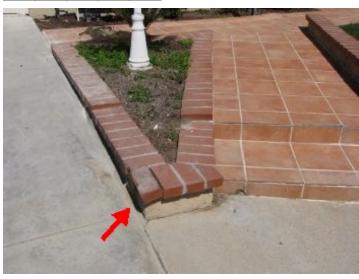
Good	Fair	Poor	N/A	None
Χ

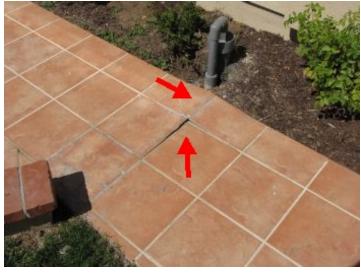
Loose bricks at walkway planter

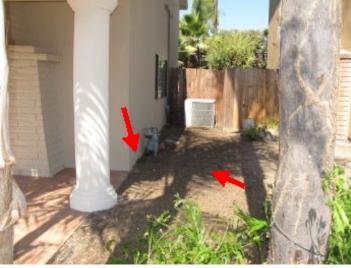
Soil at right side of house is not sloped away from foundation

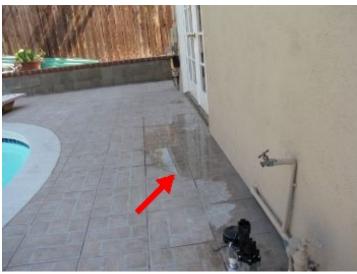
Pool deck is sloped toward house where water collects

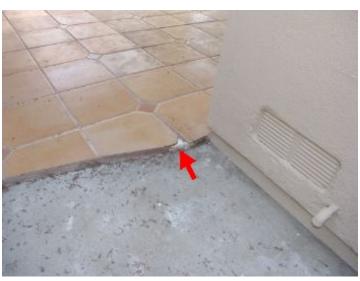
Deteriorated deck tile at rear patio area

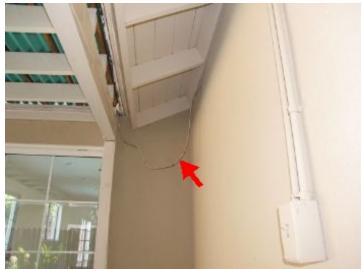
Unsecured cable wire at patio eave

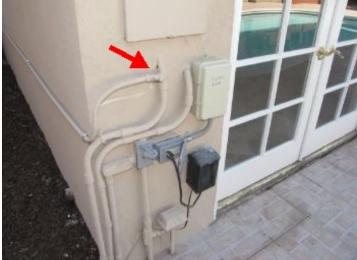
Area where conduit servicing pool equipment is broken

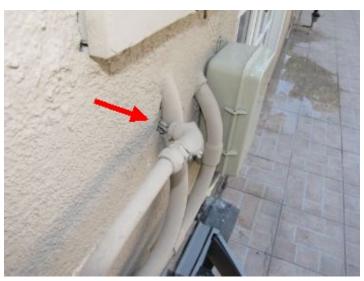
Conduit servicing pool equipment is broken

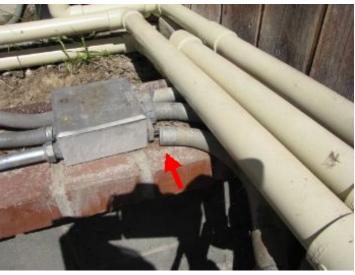
Electrical conduit at pool equipment has a broken conduit connection

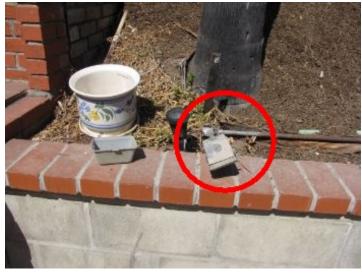
Outdoor electric functions correctly but is not secured

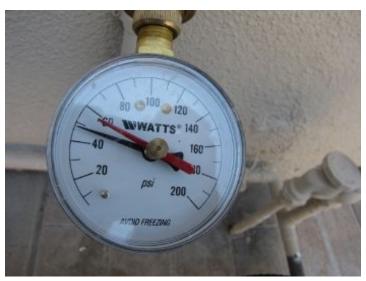
Water pressure is good at 58+ psi

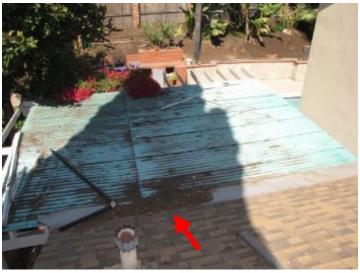
Corrugated fiberglass patio cover shows no visible means of drainage, suggest water be applied with garden hose to verify that it drains away from connection to house roof, (it may be satisfactory)

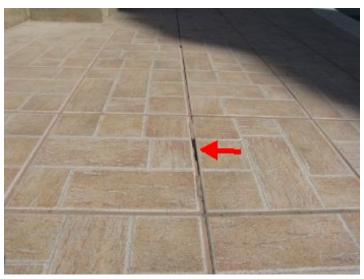
Spalling grout at pool deck

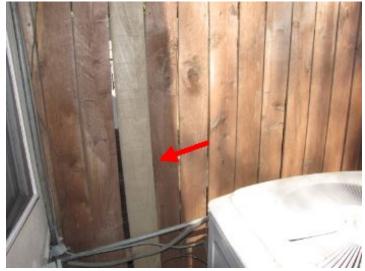
• Minor amount of fence board deterioration by pool pump area.

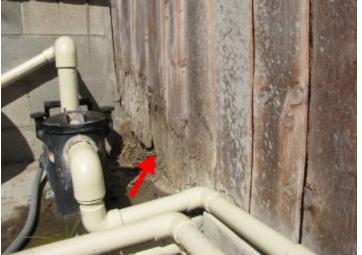
Loose fence board on right side of house

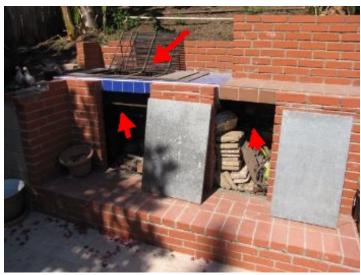
Outdoor grille is plumbed for gas but is not operable

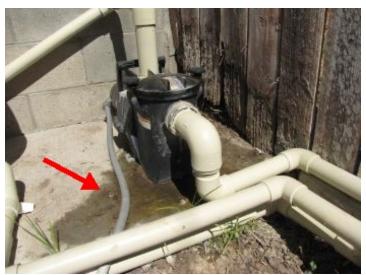
Pool pump has a water leak
